TECHNICAL REPORT REMR-CO-3

**CASE HISTORIES OF CORPS BREAKWATER
AND JETTY STRUCTURES**

Report 6

NORTH PACIFIC DIVISION

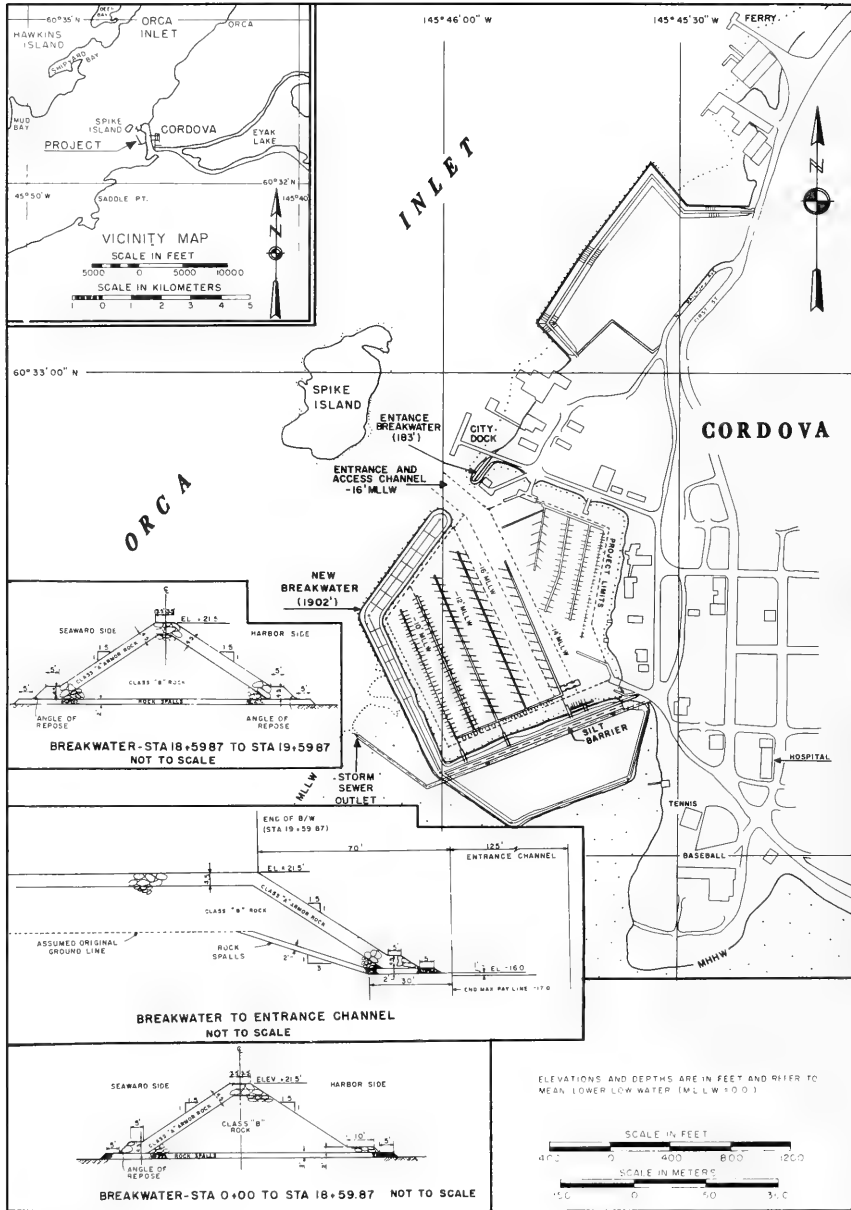
Figure 5. Site layout of Cordova Harbor, Alaska (revised 1985)

| <u>Date(s)</u> | <u>Construction and Rehabilitation History</u> |
|---|--|
| 1985 | The harbor is illustrated in Figure 5, and an aerial photograph of the harbor is presented in Figure 6. The breakwaters appear in good condition at this time. |

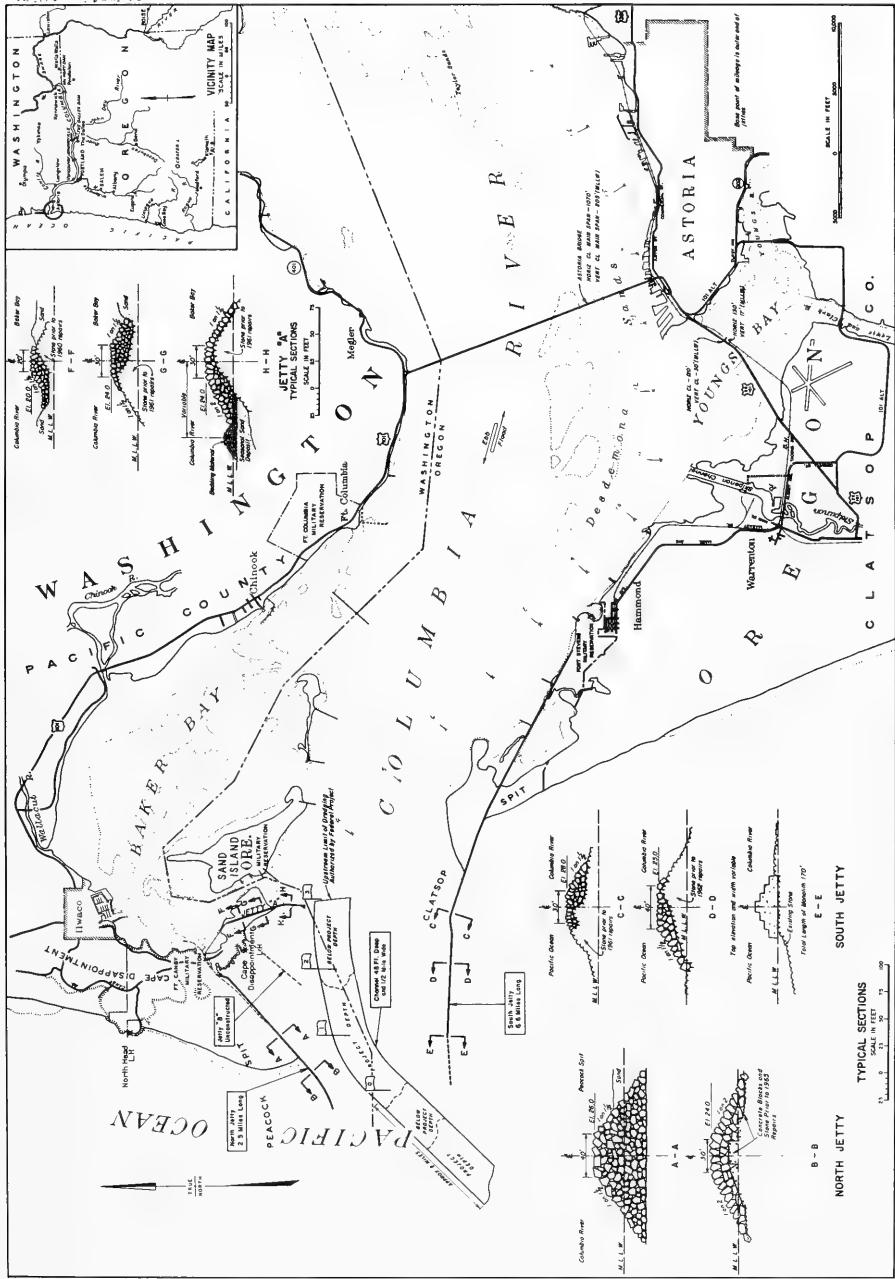
Figure 53. Site layout of Columbia River at Mouth, Oregon and Washington (revised 1979)

| Date(s) | Construction and Rehabilitation History |
|---|---|
| 1985 | The harbor and cross sections of the jetties are illustrated in Figure 53. The north jetty and training jetty "A" have scour problems at the heads. The south jetty is in need of repair. |

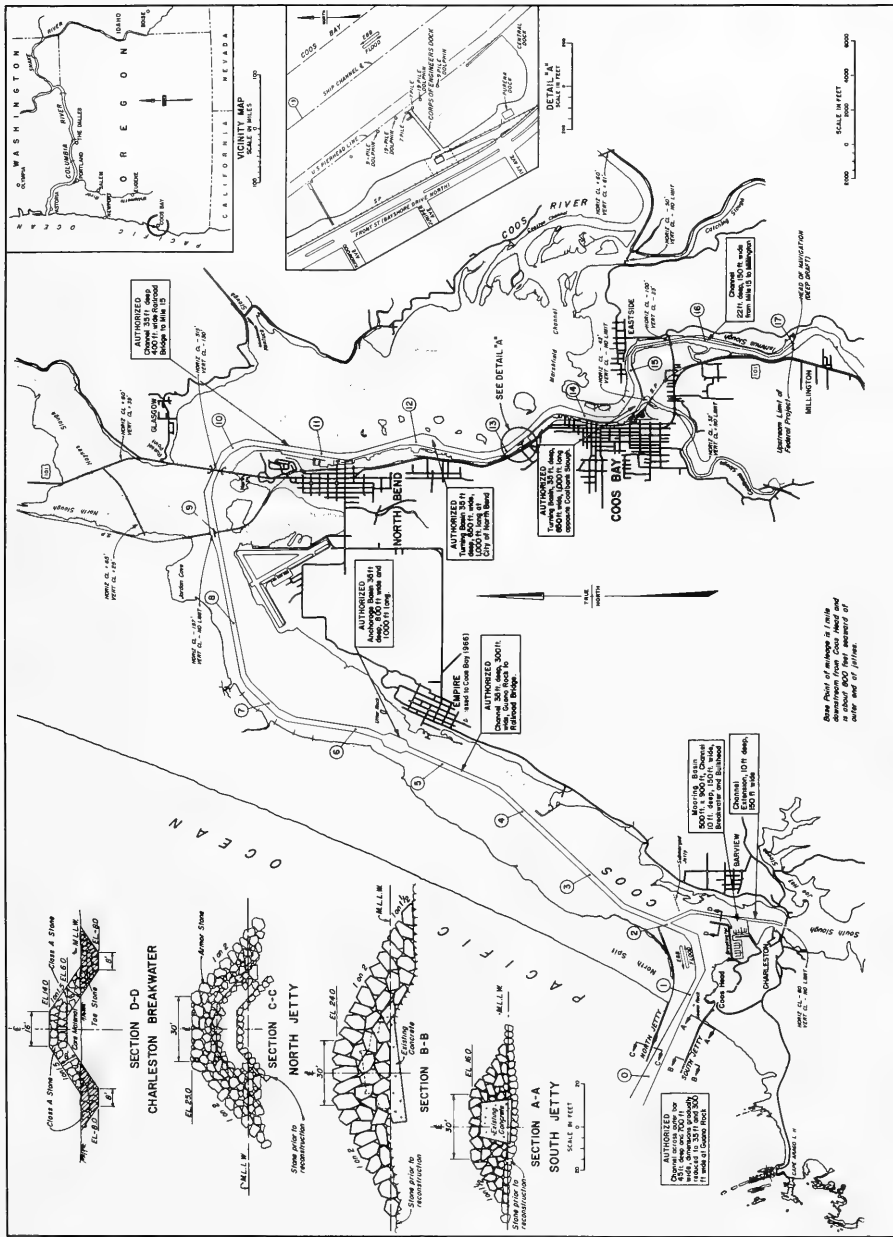
Figure 54. Site layout of Coos Bay, Oregon (revised 1979)

| Date(s) | Construction and Rehabilitation History |
|---|---|
| 1985 | The harbor and cross sections of the jetties and breakwater are illustrated in Figure 54. The south jetty is in good condition, but the outer 200 ft of the north jetty is in a deteriorated condition and has severe scour. The breakwater is in good condition. |

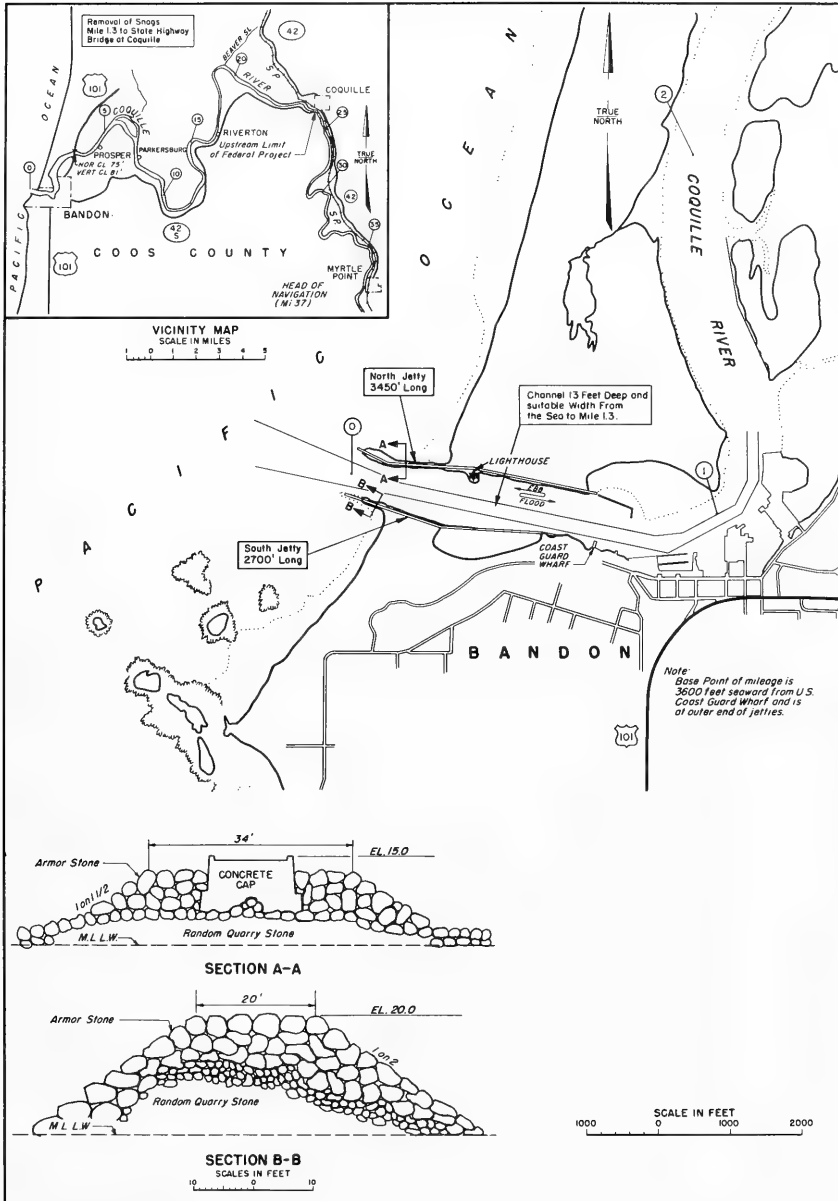
Figure 55. Site layout of Coquille River, Oregon (revised 1981)

| <u>Date(s)</u> | <u>Construction and Rehabilitation History</u> |
|---|--|
| 1985 | The harbor and cross sections of the jetties are illustrated in Figure 55. The head of the north jetty is in need of repair, but it is still functional. The south jetty is in good condition. |

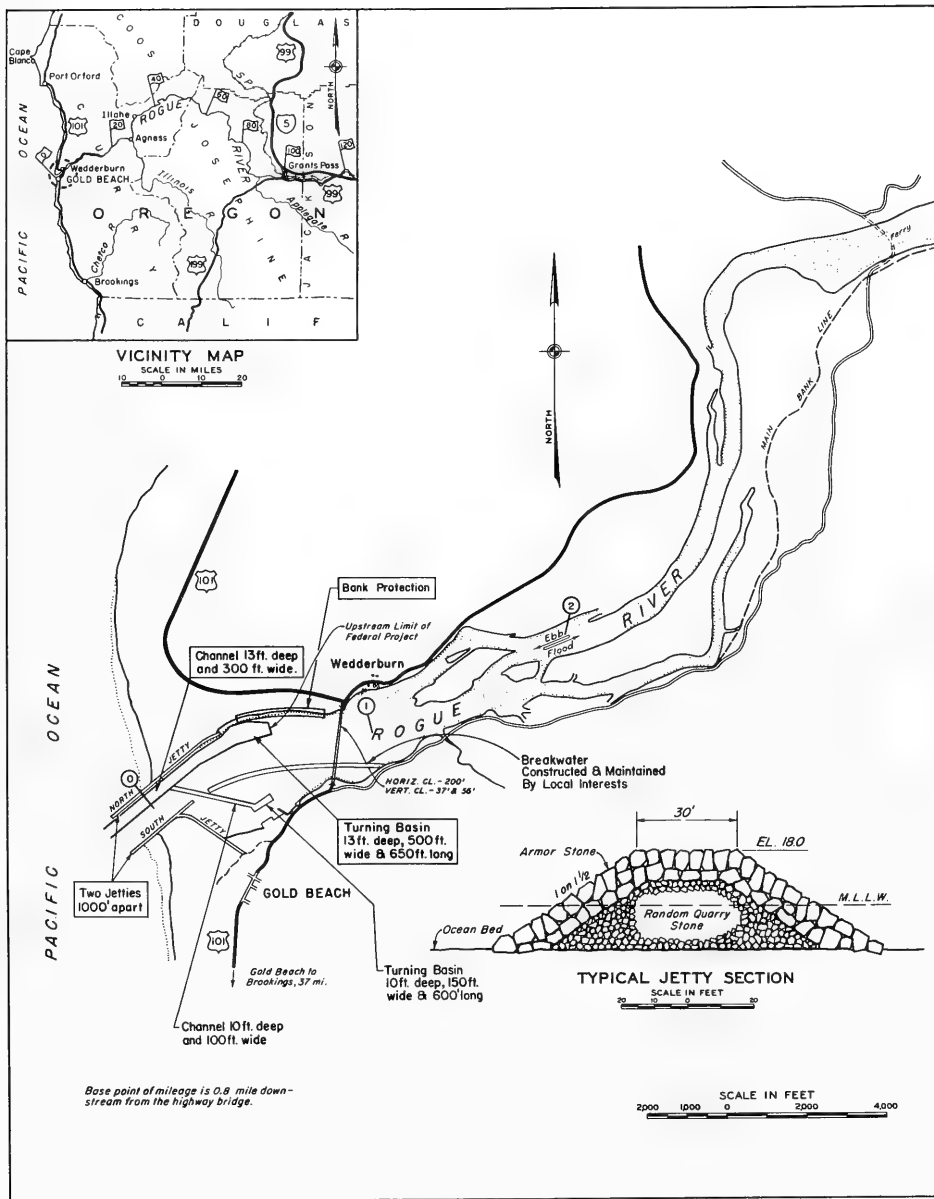
Figure 59. Site layout at Rogue River, Oregon (revised 1977)

| <u>Date(s)</u> | <u>Construction and Rehabilitation History</u> |
|---|--|
| 1985 | The harbor and cross section of the jetties are illustrated in Figure 59. There is some localized damage on the jetties. |

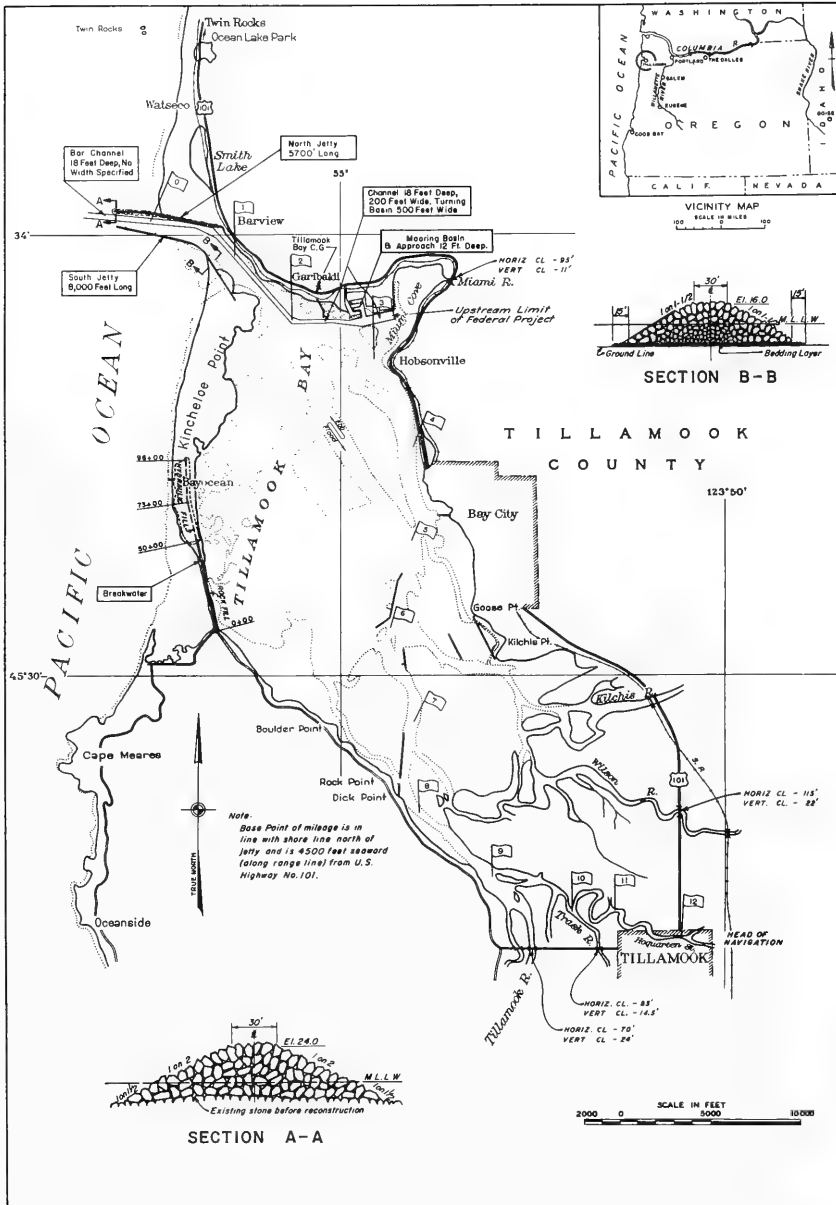
Figure 63. Site layout at Tillamook Bay and Bar, Oregon (revised 1979)

| Date(s) | Construction and Rehabilitation History |
|---|--|
| 1985 | The harbor and cross sections of the jetties are illustrated in Figure 63. The head of the north jetty has received some damage from extreme wave conditions, and the outer portion of the south jetty has shown some subsidence. No repairs or rehabilitation are planned at this time. |

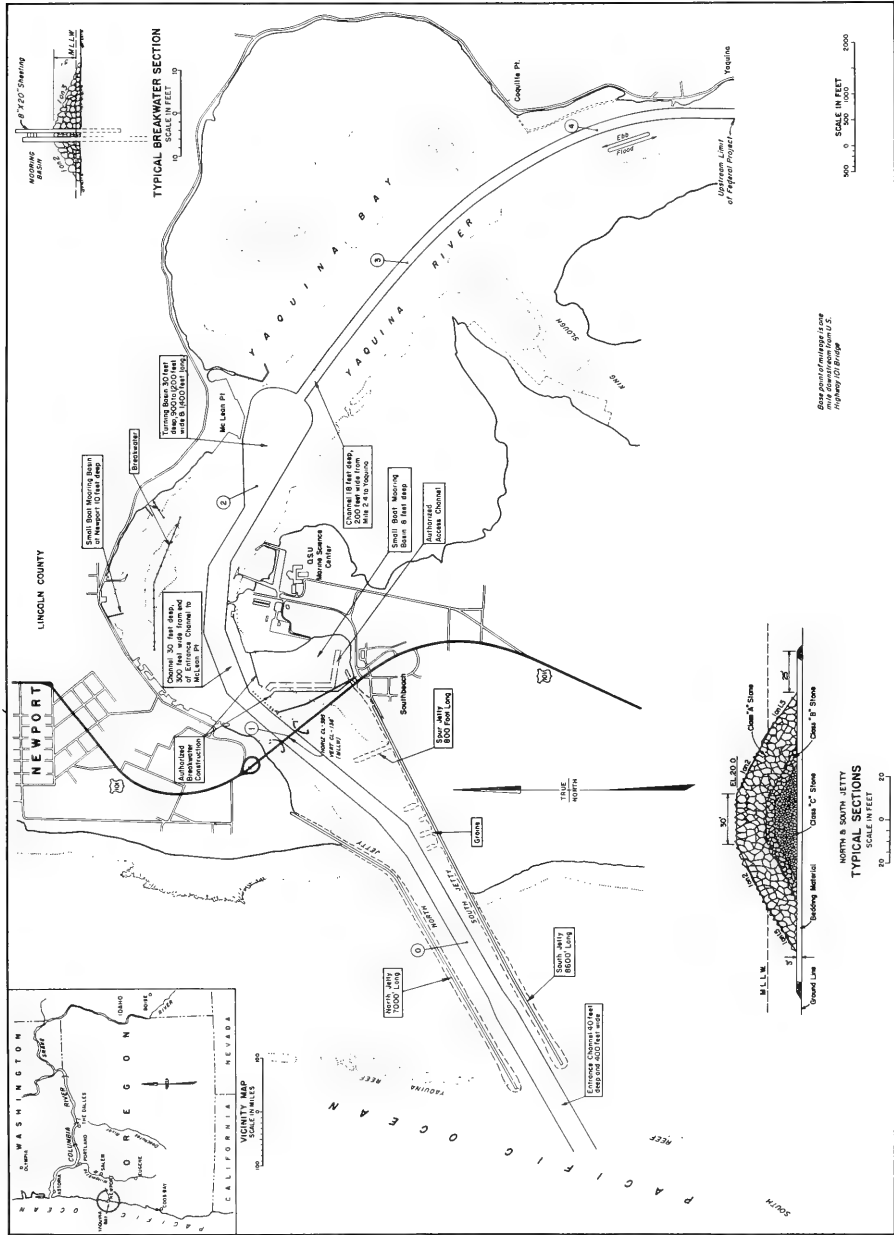
Figure 65. Site layout at Yaquina Bay and Harbor, Oregon (revised 1978)

| Date(s) | Construction and Rehabilitation History |
|---|---|
| 1985 | The harbor and cross section of the jetties are illustrated in Figure 65. The south jetty shows some damage but is serviceable, and no repairs are planned at this time. Studies are currently being conducted for major rehabilitation of the north jetty. |

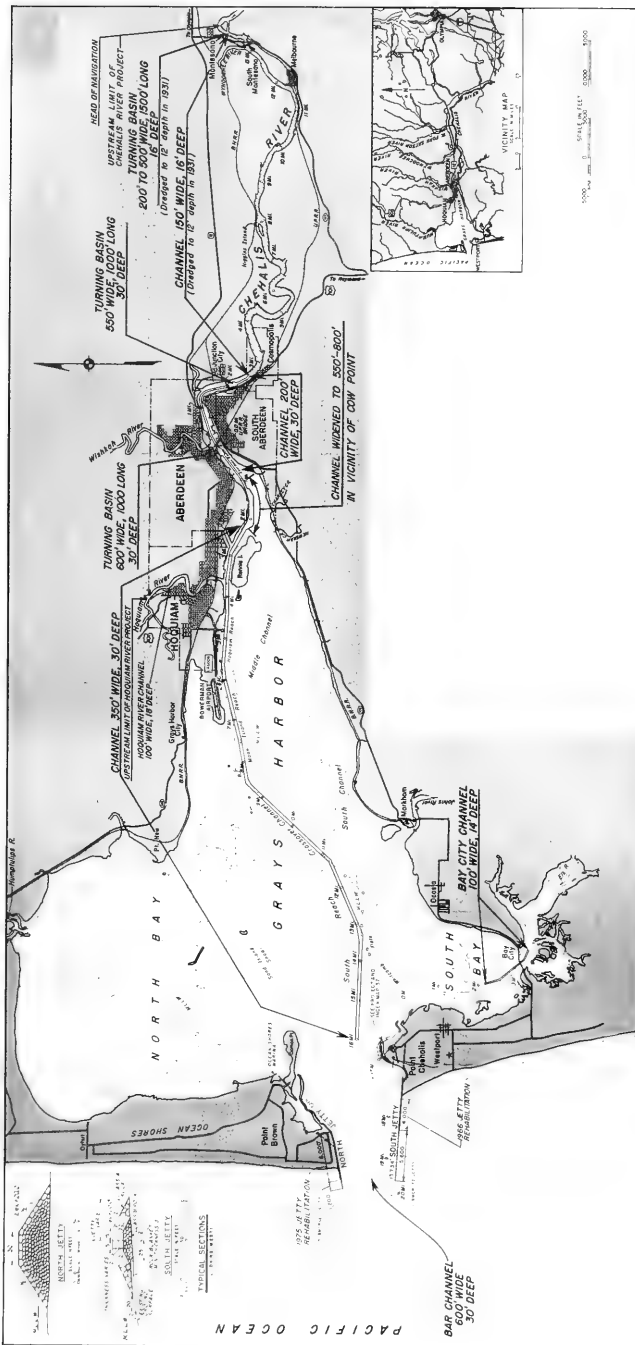
Figure 70. Site layout of Gray's Harbor, Washington

| Date(s) | Construction and Rehabilitation History |
|---|---|
| 1985 | The harbor and cross sections of the jetties are illustrated in Figure 70. The outer 1,200 ft of the north jetty and 5,600 ft of the south jetty are submerged. There is some deterioration of the south jetty, with severe scour along the channel side toe of the jetty. The overtopping conditions on the north jetty in the area of the 1975 rehabilitation work threatens a roadway on the land side of the jetty. |
